The Motion Tech News

Screw Jack Help and Repairs

Getting customers screw jack working again for rail lift

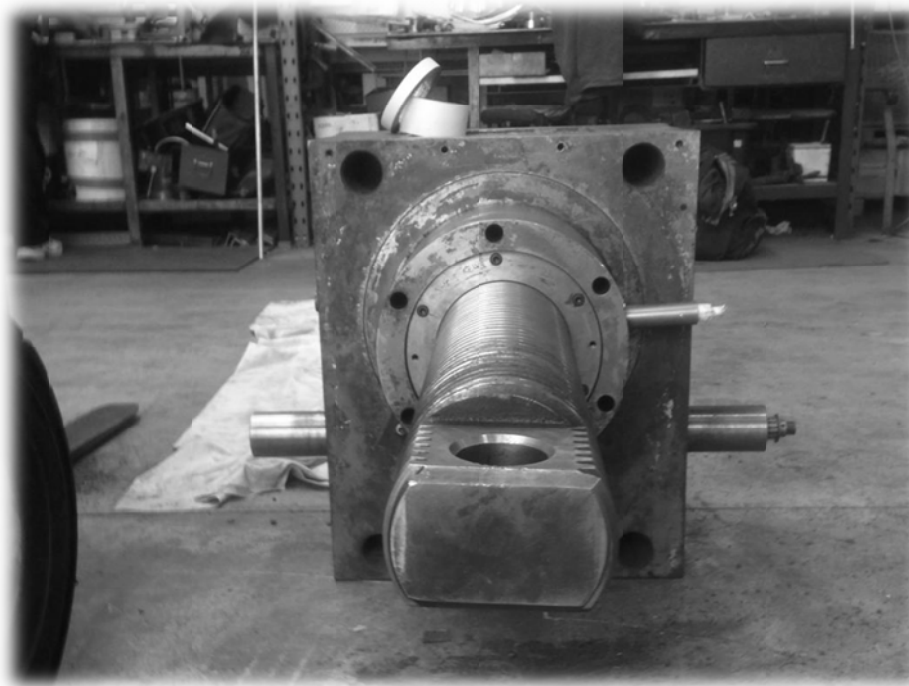
This is a typical application for Motion Technologies, as we are known in the industry for our sound knowledge in screw jacks. This above screwjack was originally manufactured in the early 70's by Unimec for lifting the end of a train to remove the bogie. It has 120 ton lifting capacity with a 200mm diameter screw that strokes 2.2 metres. The customer rang in desperation, as his local machine shop could not repair and asked us to take a look. We received the screw jack in pieces which totalled 1.5 ton in weight. What was evident is that the screw jack was over stroked causing some damage to the bronze worm wheel. Additionally the grease lubrication was non existent. This can be a problem on type 1 screw jacks where the lubrication of the gearbox is lost.

Type 1 Screw jack means the screw translates through the gearbox.

Due to the damage on the worm wheel, we suggested a safety nut be fitted in the event of failure. A safety nut is essentially another nut fitted to the screw and is driven by pins from the main worm wheel. It is no load bearing thus does not wear out.

If and when the worm wheel losses all its thread for the translating screw, the safety nut slides down on its pins to the worm wheel and then becomes load bearing. This then stops the load on the screwjack from collapsing the actuator. A proximity sensor was fitted to the safety nut, so if activated the drive motor driving the screw jack stops. The jack was returned to a happy customer.

Additionally, we wanted more lubricant on the main lift screw as well as if you have lubricant under mechanical pressure then the materials don't wear out. We proposed changing to oil lubrication and fitted a gravity oil tank to the screw jack gearbox housing and converted the anti rotation tube into a oil tank. Now the safety nut and gearbox has oil lubricant everytime it operates.

Additionally the customer changed the operation cycle to fully collapse "retract" the lift screw which in turn implies the screw has oil lubrication over it entire length on every cycle. To monitor oil loss a dip stick is fitted with predefined minimum and maximum level marks.
